**Docket No. 217 – Development and Management Plan Inspection**

Northeast Utilities Service Company Certificate of Environmental Compatibility and Public Need for the construction of a 345-kV electric transmission line and reconstruction of an existing 115-kV electric transmission line between Connecticut Light and Power Company's Plumtree Substation in Bethel, through the towns of Redding, Weston, and Wilton, and to the Norwalk Substation in Norwalk, Connecticut.

**Date:** May 4, 2006

**Location:** 115 kV Underground Route

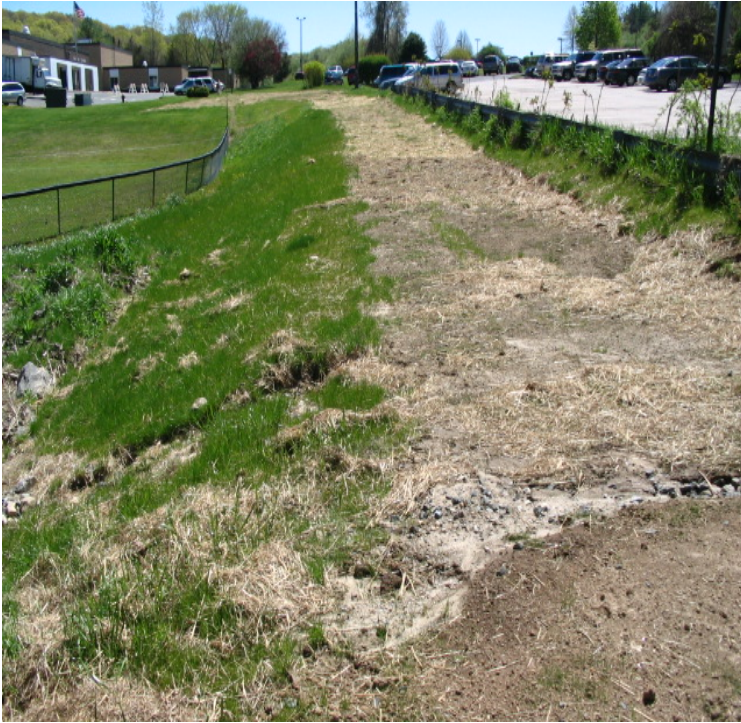
115kV (Bethel Ed., Rt 58): Photo on the left shows the ROW near the north tower where grass is starting to grow in the recently restored area. Photo on the right shows grass growth in the vault area across from Putnam Park. 5/4/06

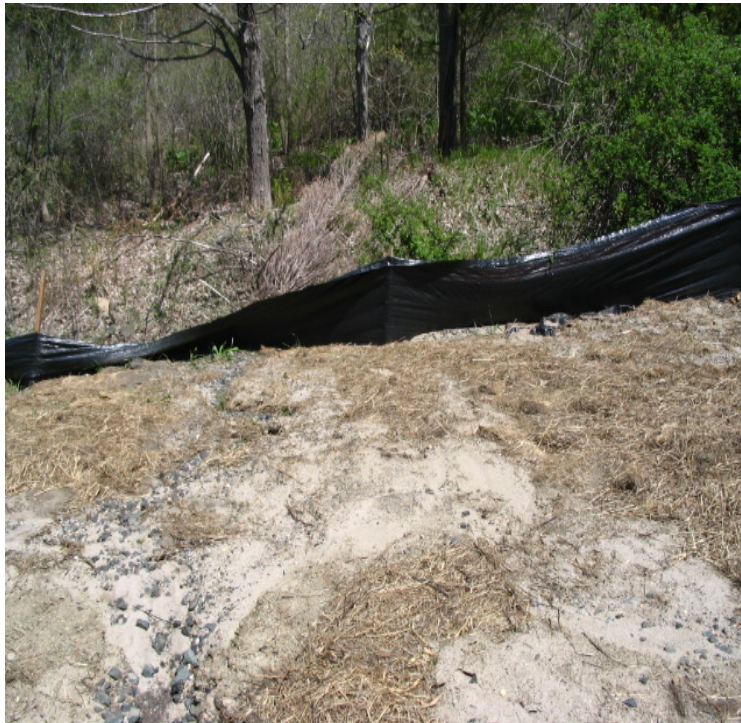
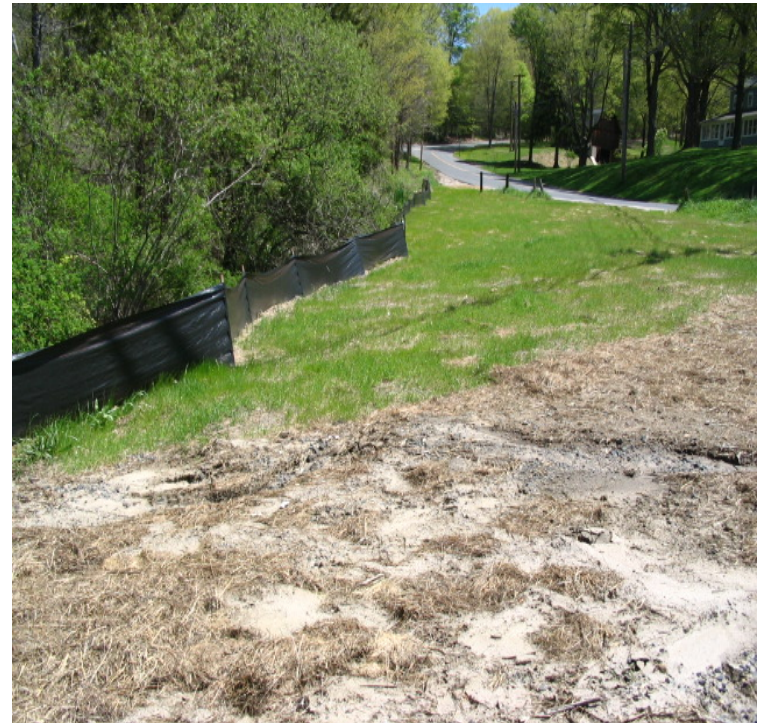
115kV (Sunset Hill): Both photos show a view of the storage area. Silt fence could be removed adjacent to the area where grass is growing well, but fence should remain adjacent to the portion which is not yet vegetated. It is working well to prevent sedimentation. 5/4/06
